Inspection Report

Mine Name: Walker Flat
Operator Name: Miracle Rock Mining and Research

Permit number: S0150081
Inspection Date: April 12, 2007
Time: 8:20-8:40 AM

S0150081, Walker Flat Mine, Miracle Rock Mining and Research

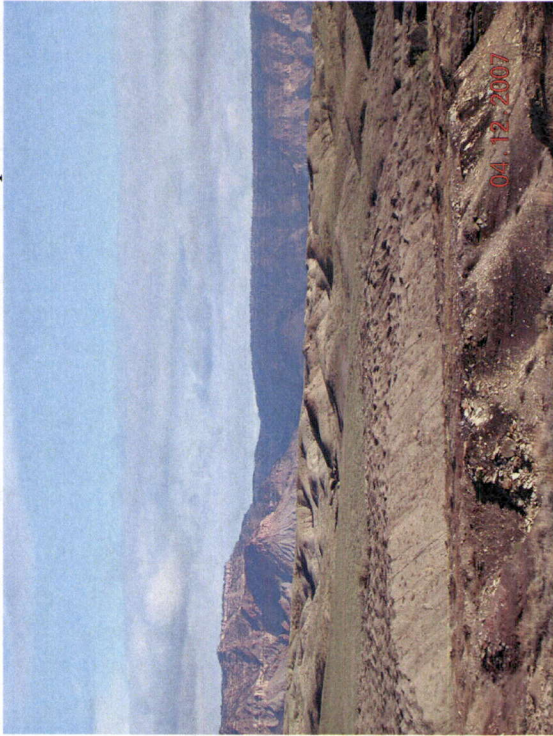
There were no signs of erosion problems. I expect the gouges to provide good erosion control.

Photo 1. This photo and Photo 2 are overviews of the disturbed area. Note the roughening.

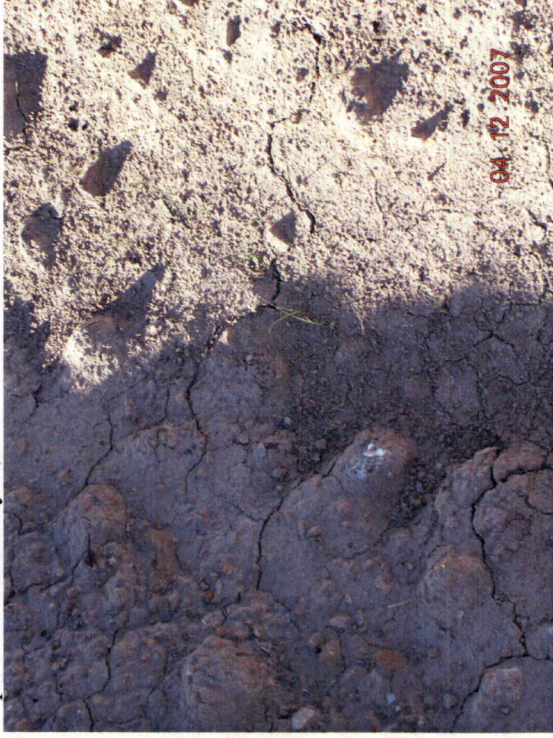
The area was seeded in the spring of 2006, but I do not believe there was any growth in 2006. During this inspection, I found numerous grass seedlings in the depressions. I believe much of the seed was able to survive the summer and is now growing.

Photo 3. Many of the depressions have grass seedlings.

The Division and the operator need to continue to monitor the site. Although the grass has germinated, it needs to receive continued moisture during the spring for it to become established.

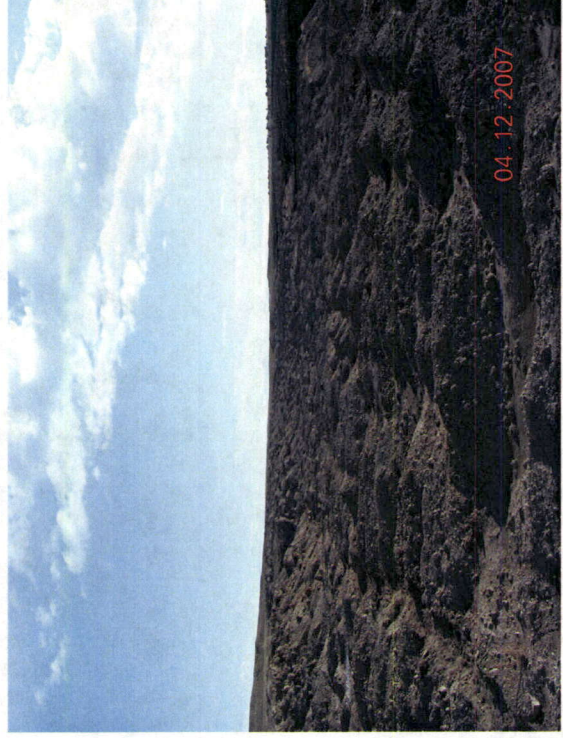
Photo 4. A closer view showing the roughening.
